# Moab UMTRA Project Flood Response Summary 2008

January 2009

U.S. Department  
of Energy

## **Office of Environmental Management**

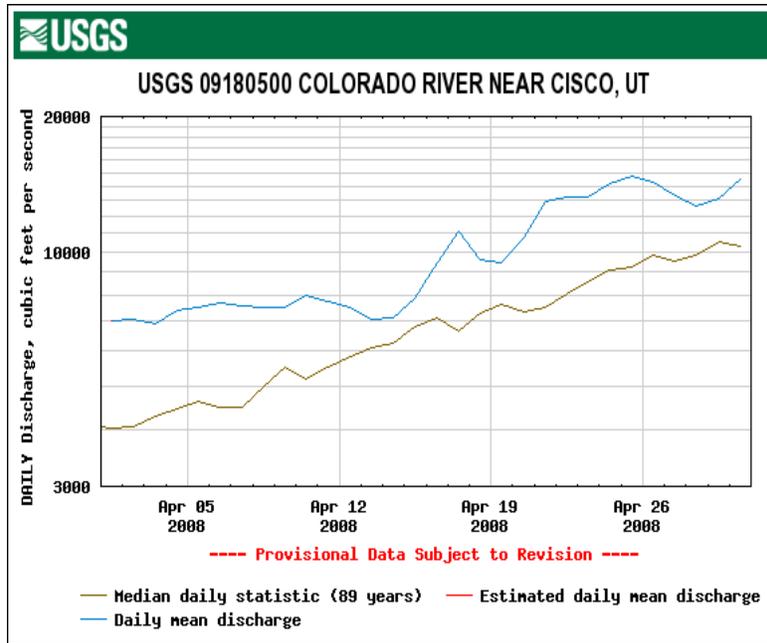
Figure 1. April 2008 Colorado River Daily Mean Discharge and the Station Average Discharge Measured at the USGS Cisco, Utah, Gaging Station.

- Week ending April 4, NOAA forecasted the seasonal runoff to be 140 percent of average at the Cisco Gaging Station. River flow at the Cisco gage varied from 5,880 to 7,410 cfs (Figure 1).

- Week ending April 11, 400 sandbags were stockpiled on site. River flow at the Cisco gage varied from 7,490 to 7,980 cfs (Figure 1).
- Week ending April 18, elevation surveys were conducted across the river berm and the berm that runs along the southeast end of the tailings pile. The purpose of the survey was to indentify low portions of the berm and to compare elevation data onsite. River flow at the Cisco gage varied from 7,080 to 11,100 cfs (Figure 1). The snow pack snow water equivalent exceeded the maximum measured in the Upper Colorado Basin during this week (Figure 2).

- Week ending April 25, reject sand was ordered and placed along the lower areas of the berm, and an extra 500 sandbags were ordered, bringing the total to more than 750 sandbags on site. River flow at the Cisco gage varied from 9,490 to 14,700 cfs (Figure 1). Photos were taken of the backwater areas to document the preflood channel morphology (Appendix C). By April 22, the backwater channels adjacent to the site were inundated with water when flows reached approximately 13,000 cfs.

- The highest daily average flow in the month of April 2008 was 14,700 cfs on April 25 (Figure 1).

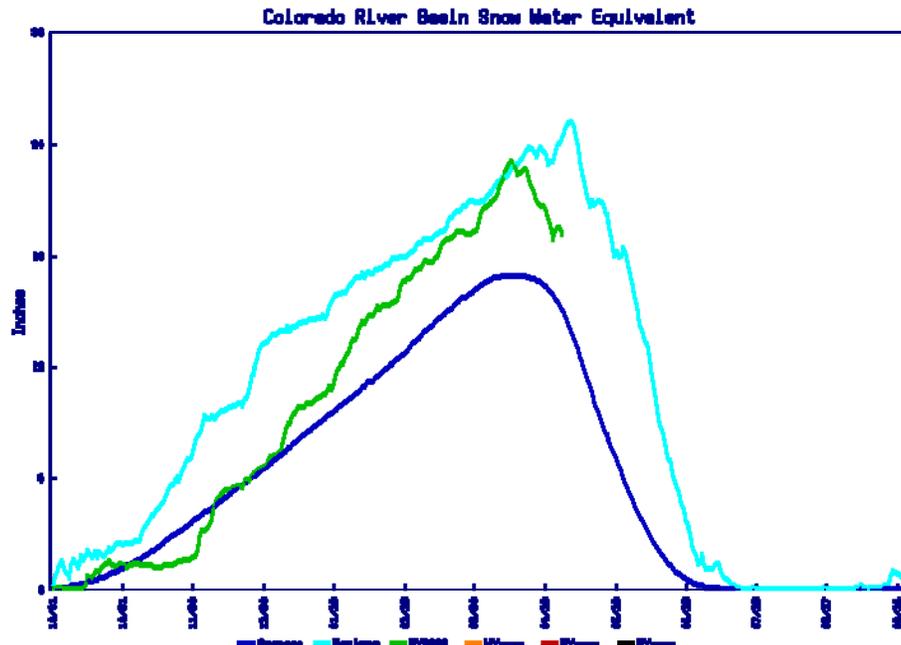
Figure 2. Snow Water Equivalent for the Upper Colorado River Basin During the First Week of May 2008. The Light Blue Line Represents the Maximum Snow Water Equivalent Observed, the Dark Blue Line Indicates the Average, and the Green Line Represents the 2008 Conditions.

- Week ending May 2, the well field storage trailer, port-a-potty, and shed were relocated from the well field to higher ground near the trailer staging area. These structures were moved before the action level designated in the *Flood Mitigation Plan* (DOE-EM/GJ1640) due to personnel issues and scheduling. River flow at the Cisco gage varied from 12,700 to 16,700 cfs (Figure 3), or 118 percent of average. The snow water equivalent was above average for this week (Figure 2).

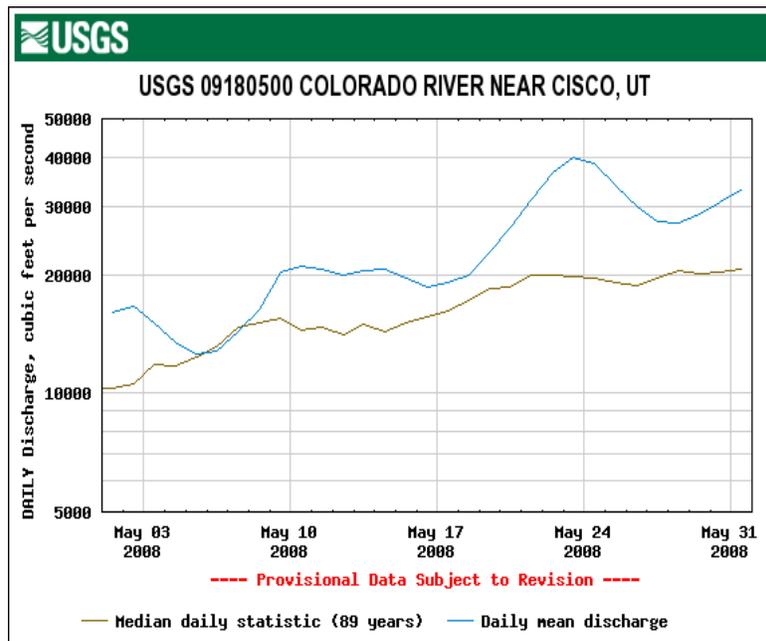
Figure 3. May 2008 Colorado River Daily Mean Discharge and the Station Average Discharge Measured at the USGS Cisco, Utah, Gaging Station.

- Week ending May 9, NOAA predicted the seasonal runoff volume to be 133 percent of normal, and the snowpack in the Upper Colorado River Basin was 129 percent of normal. An additional 1,000 sandbags were ordered, and a total of 500 sandbags were filled and loaded onto pallets on site. The site-wide elevation data indicated that the river would begin to flood the well field when the gage on the river pump station reached 7 ft, which is equivalent to an elevation of approximately 3,967 ft (mean sea level). The gage measurements versus river flow were recorded throughout May and June 2008 (Figure 4). River flow at the Cisco gage varied from 12,600 to 20,400 cfs (Figure 3), or 102 percent of average for the week.

- Week ending May 16, the snowpack was 154 percent of normal. The well field extraction rate was increased in order to ensure sufficient volume in the evaporation pond in preparation for well field shutdown due to high river flow. River flow at the Cisco gage varied from 18,700 to 20,800 cfs (Figure 3), or 115 percent of average for the week.

- Week ending May 30, the well field remained nonoperational, and the river flow at the Cisco gage varied from 27,100 to 38,500 cfs (Figure 3), or 141 percent of average for the week.

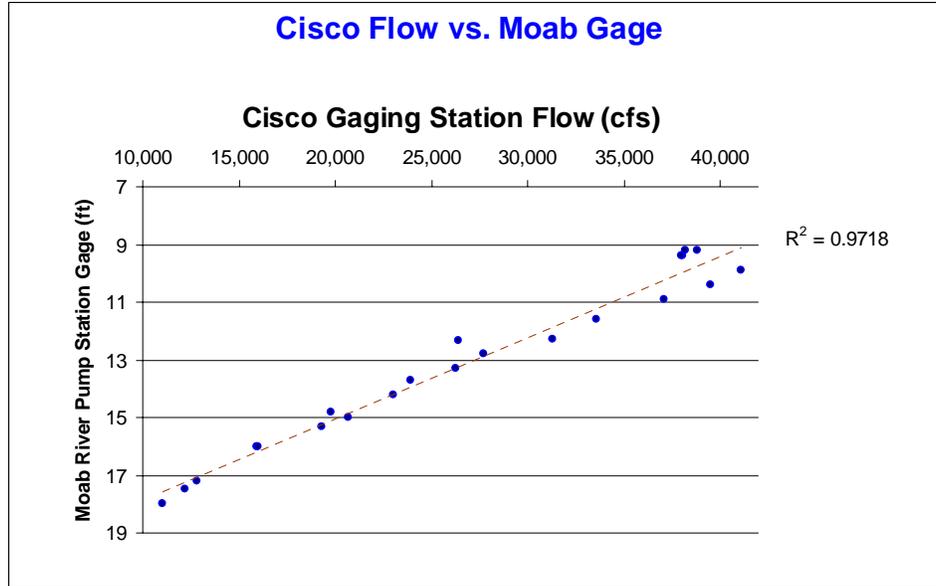
Figure 4. A Comparison of the Colorado River Flow at the Cisco Gage and the Staff Gage at the Moab Site Freshwater Pump Intake Structure.

Throughout the spring runoff season, the painted gage on the freshwater pump was monitored in order to relate the Cisco Gage to the river flow near the Moab site. While using this gage was helpful in determining the river elevation, it is difficult to read and may not be accurate. A USGS river gage with large ticked number indicators was purchased after the runoff event and will be installed in early 2009. This will allow a more accurate documentation of the river elevation at the Moab site.

Based on the river flows measured at the Cisco station and the actual elevation measured at the site, the conservative action levels may be updated. Extrapolating the river stage elevation data collected from the site pump intake structure, the well field would not flood until the river stage measures 7 ft on the gauge (based on elevation). Still adhering to the use of a conservative action level, flows in excess of 45,000 cfs can be considered as the level at which the well field berm located on the river bank will be breached.

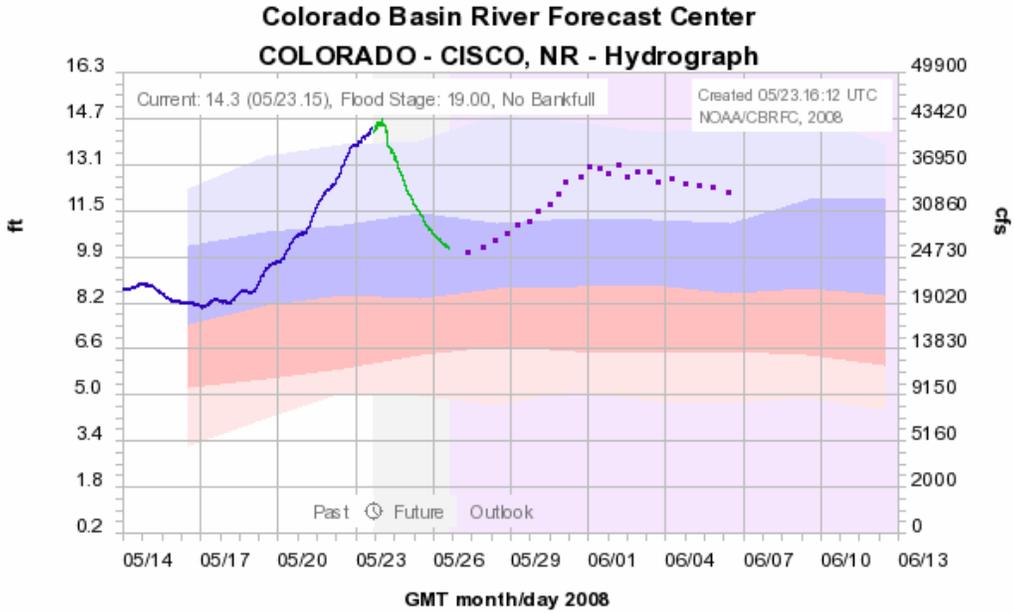
Figure 5. The Hydrograph on May 21 that Indicated Flows Would Reach Nearly 43,000 cfs by May 23.

- On May 21, NOAA forecasted the river flow to reach over 40,000 cfs on May 23 (Figure 5). In response, the extraction wells were shut down, and the controllers and flowmeters were removed from the vaults. Sandbags were placed around the infiltration shed, transformers, along the low portions of the berm, along the Moab Wash (at the north end of the well field and across the well field access road), and across the road at the south end of the well field (Appendix A). Extra supplies and materials, such as the metal Configuration 2 vault lids, were removed from the well field and brought to higher ground. The snowpack was at 144 percent of average. The highest daily average flow for the month was 40,100 cfs on May 23 (Figure 3). A rapid moving cold front caused an abrupt decrease in river flow, possibly preventing significant flooding on site. The river was approximately 1 ft from the sandbags on the berm in most locations. The adjacent (Policaro) property flooded across the access road, and the well field access road was blocked by water from Moab Wash (Appendix A). River flow at the Cisco gage varied from 19,100 to 40,100 cfs (Figure 3). The average flow was 122 percent of average during the week, and the snow water equivalent was still above average, but had significantly decreased (Figure 6).

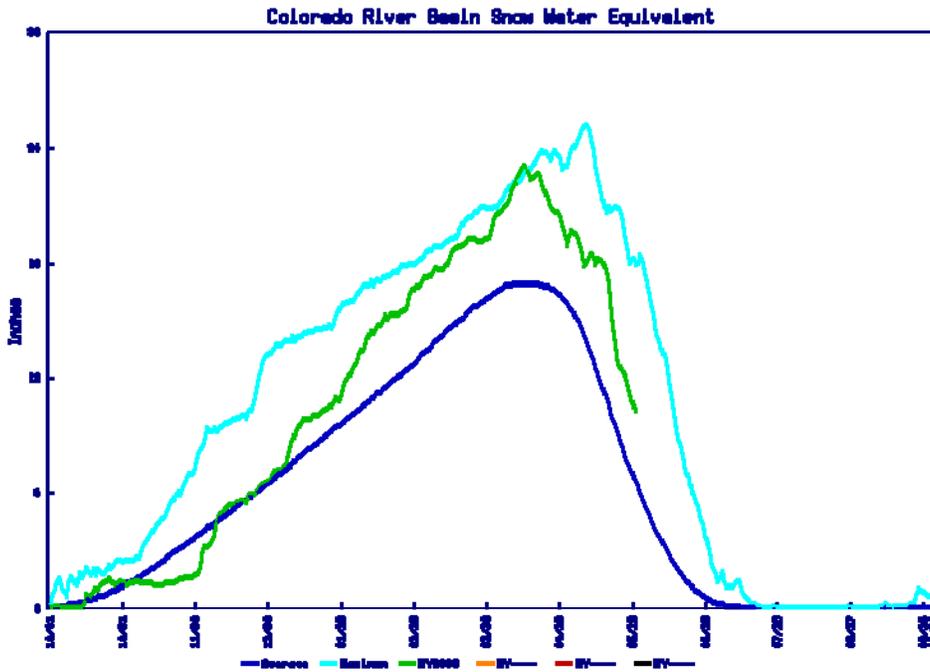
Figure 6. By Late May 2008, the Snow Water Equivalent Had Greatly Decreased from Early May 2008, but Was Still Above Average.

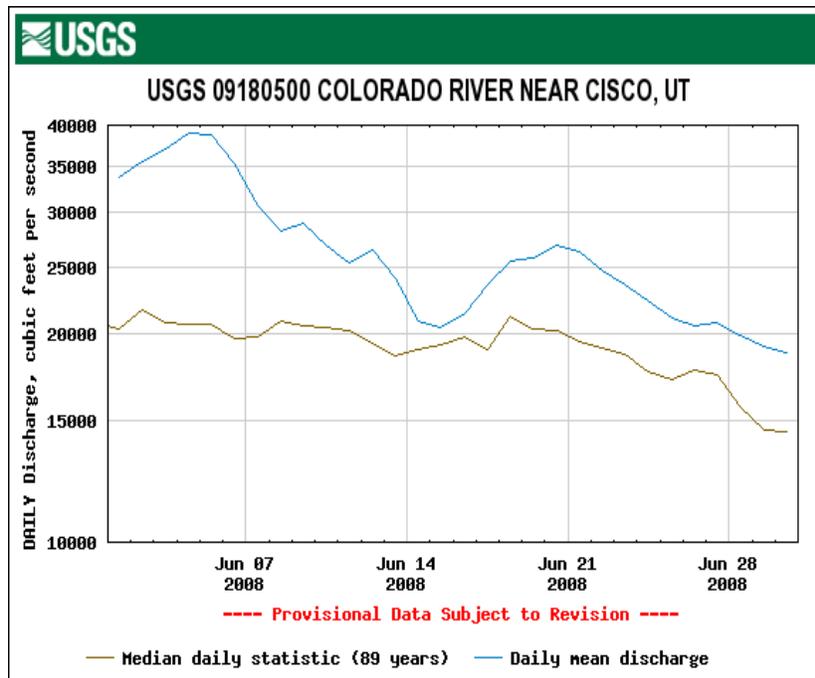
Figure 7. June 2008 Colorado River Daily Mean Discharge and the Station Average Discharge Measured at the USGS Cisco, Utah, Gaging Station.

- Week ending June 6, the river peaked again at 39,500 cfs on June 4 (Figure 7), and the water continued to enter the adjacent (Policaro) property. It was noted that approximately 6 inches of ground water had seeped into the Configuration 4 and Infiltration Trench vaults. On June 4 the ground water was approximately 4 ft below ground surface (bgs) in the well field. The extraction system remained nonoperational during this week. At this time, the snowpack was 139 percent of average. River flow at the Cisco gage varied from 32,900 to 39,500 cfs, and the average flow was 146 percent of average during the week (Figure 7).

- Week ending June 13, the snowpack was 128 percent of average. River flow at the Cisco gage varied from 24,600 to 31,000 cfs (Figure 7), and the average flow was 127 percent of average during the week.

- Week ending June 20, Configurations 1 and 3 were brought back online June 19. The snowpack was 112 percent of normal (Figure 8). River flow at the Cisco gage varied from 21,000 to 26,900 cfs (Figure 7) or 102 percent of average for the week.

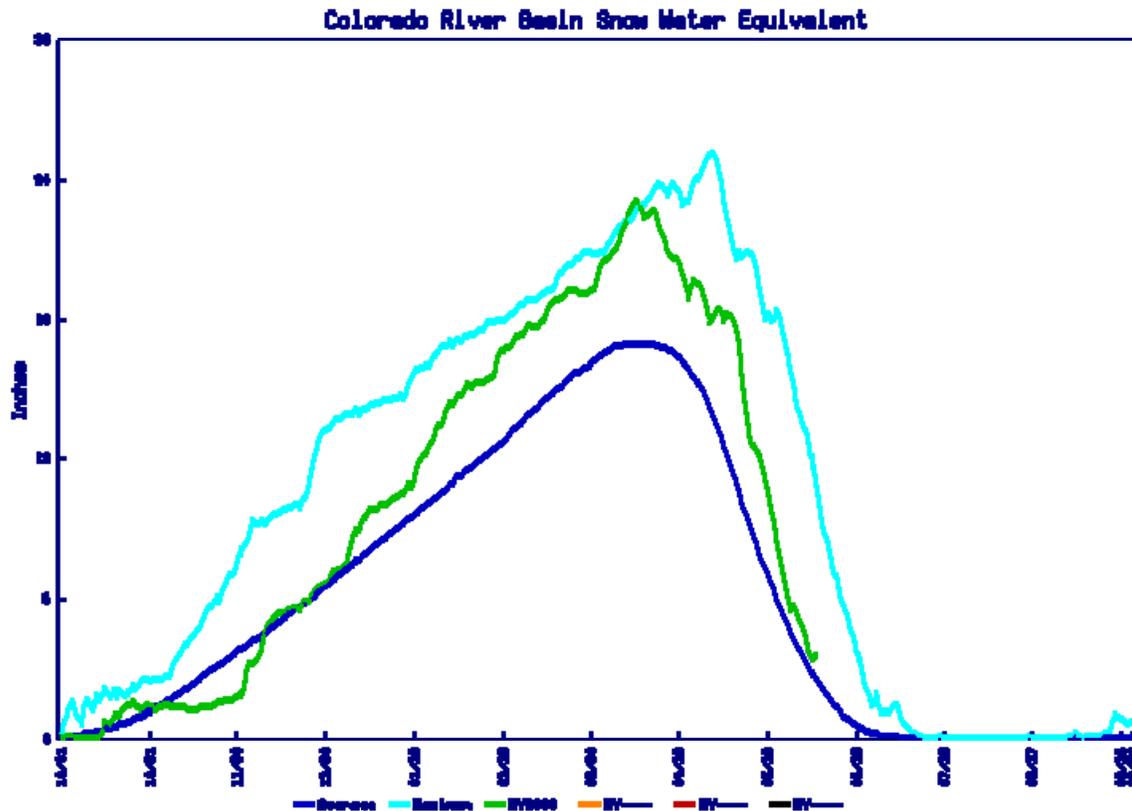
Figure 8. By Mid-June 2008, the Snow Water Equivalent Was Near Average.

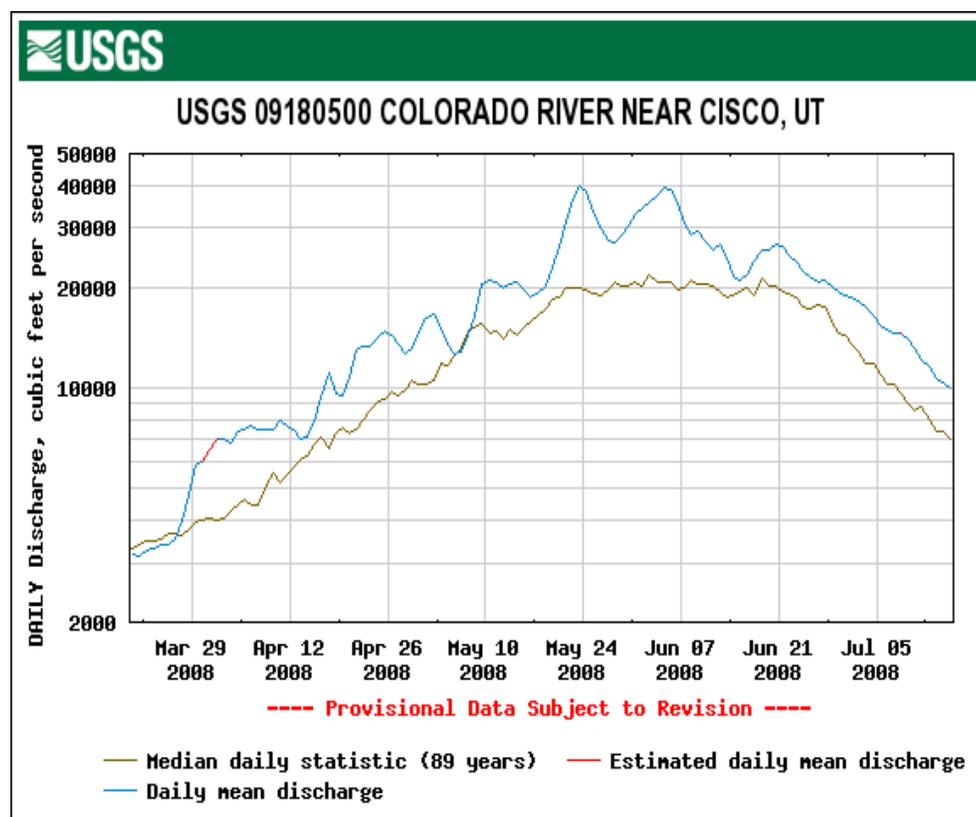
While the Colorado River flows increased to 39,000 cfs on both May 23 and June 4, 2008, the Moab site was spared from flooding and loss of property (Figure 9). The only observed flooding was on the adjacent (Policaro) property, along the Moab Wash, and in a few vaults in the well field. It should be noted that flooding along the adjacent property was greater in 2008 than in 2005, even though the 2005 flow was higher. The difference is likely due to the remediation and recontouring of that property which took place in 2007. As further remedial activities take place on the Moab UMTRA site, it is important to assess how an increased river flow may impact these locations.

Figure 9. Late March Through Early July 2008 Colorado River Daily Mean Discharge and the Station Average Discharge Measured at the USGS Cisco, Utah, Gaging Station.

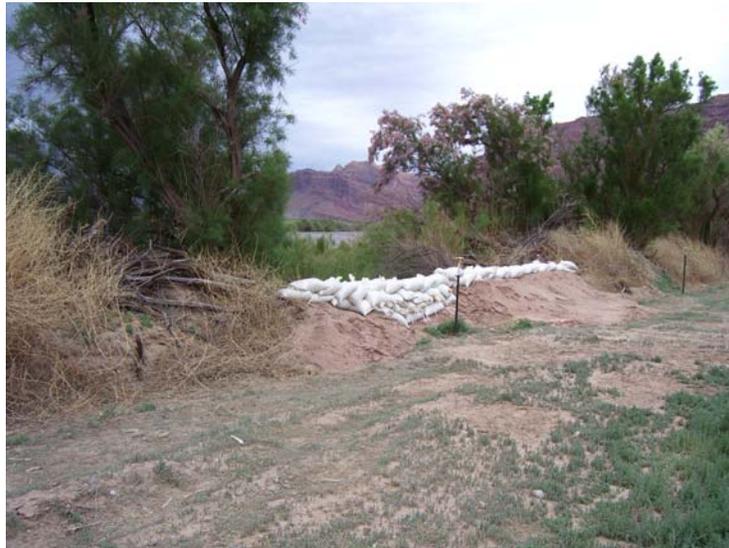
*Sandbags Placed Along the Baseline Well Point Access Path.  
Photo Taken May 21, 2008.*

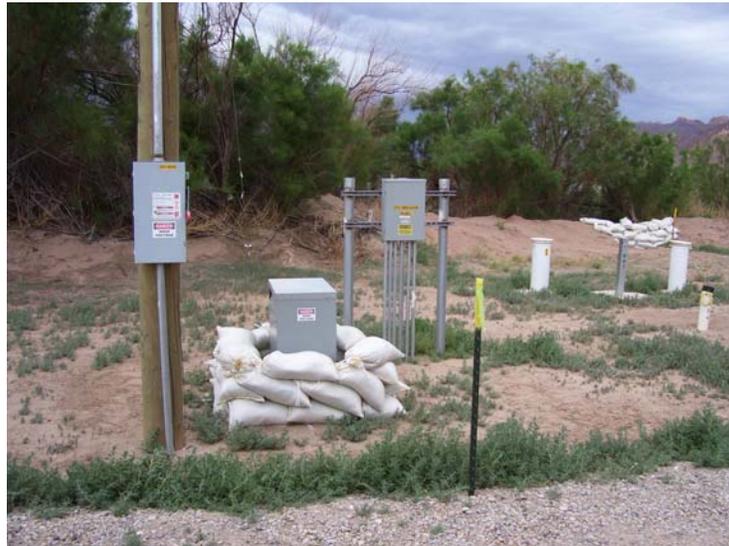
*Sandbags Placed Around the Transformer in Configuration 3.  
Photo Taken May 21, 2008.*

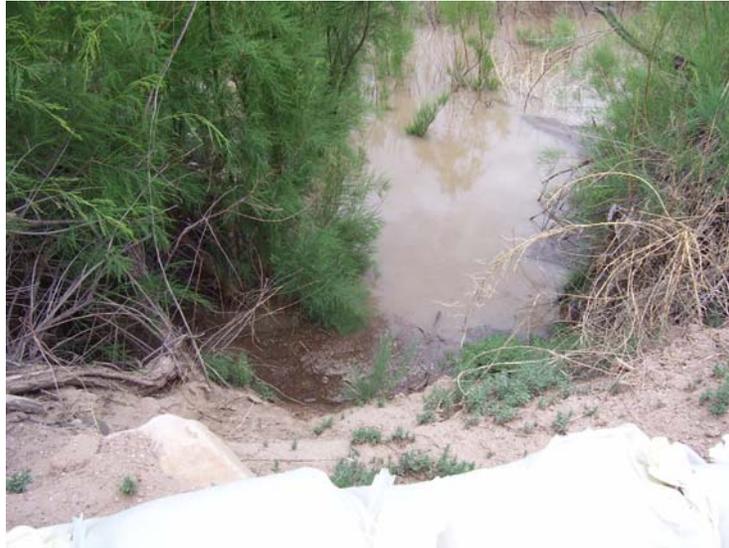
*Location of the River in Comparison with the Baseline Sandbags.  
Photo Taken May 21, 2008.*

The river had reached several of the sandbagged areas along the riverbank, but never breached into the well field. River water backed up into Moab Wash past the lower crossing. The water was approximately 3 to 4 ft deep along the crossing, but remained confined to the channel.

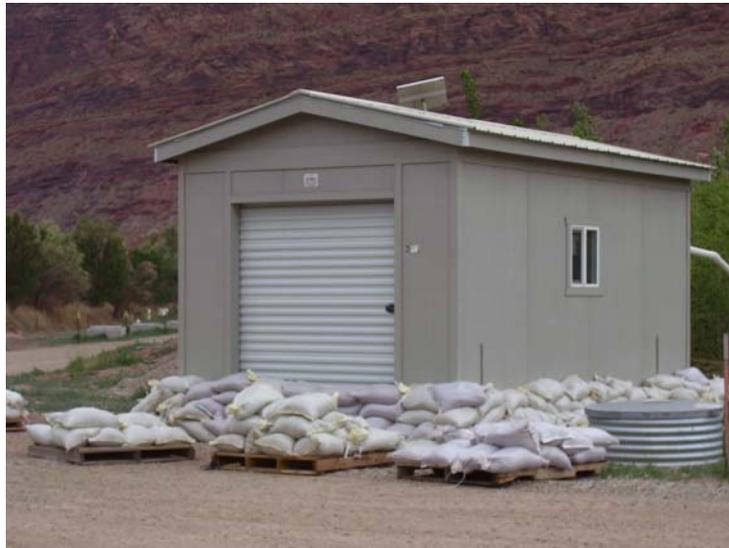
*Sandbags Placed Around the Infiltration Filter Shed.  
Photo Taken May 21, 2008.*

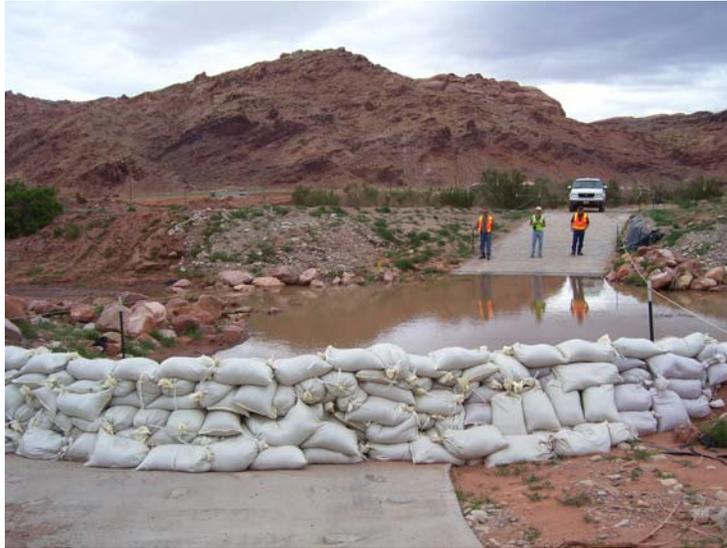
*Sandbags Placed Around the Well Field Access Road.  
Photo Taken May 21, 2008.*

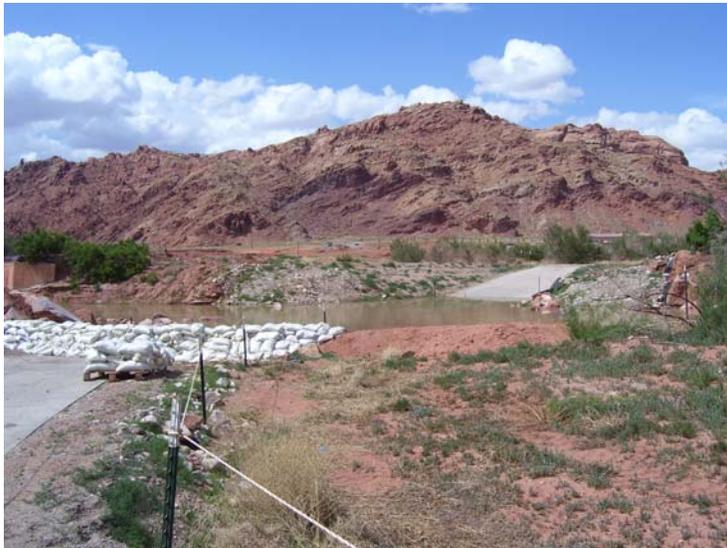
*The Well Field Access Road During Maximum River Flow.  
Photo Taken May 23, 2008.*

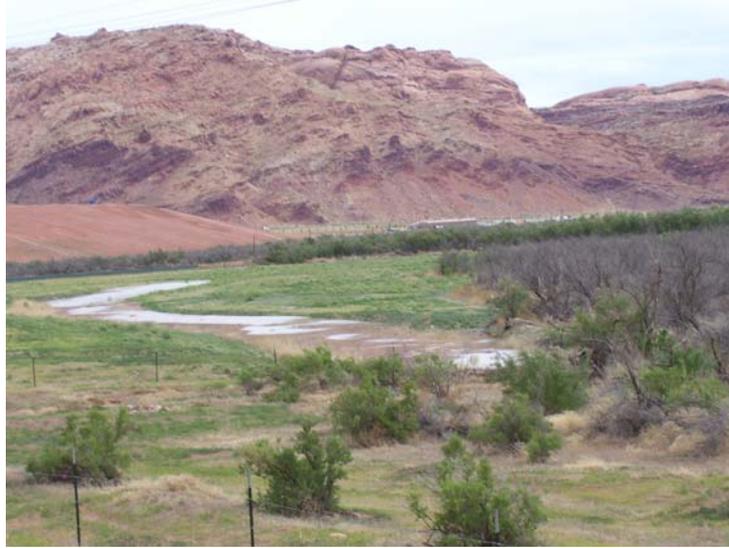
*Surface Water Flooded on the Adjacent (Policaro) Property Forming a Channel, Facing Northwest. Photo Taken May 23, 2008.*

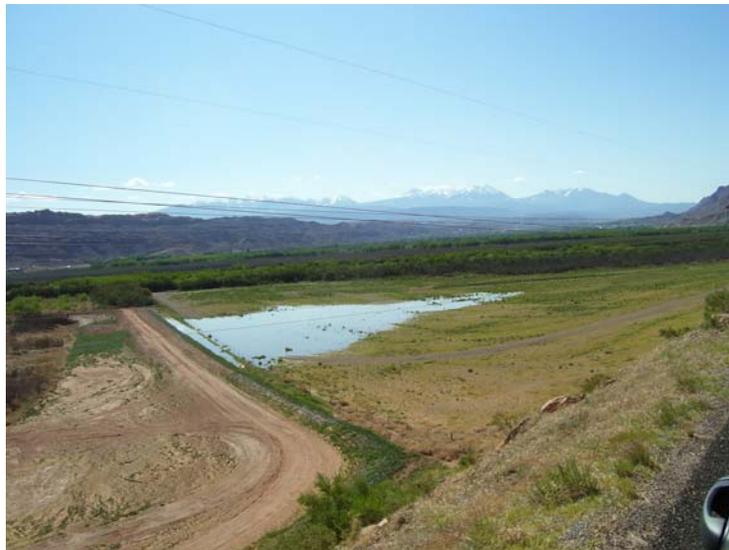
*Surface Water Spillover on the Adjacent (Policaro) Property. Photo Taken May 27, 2008.*

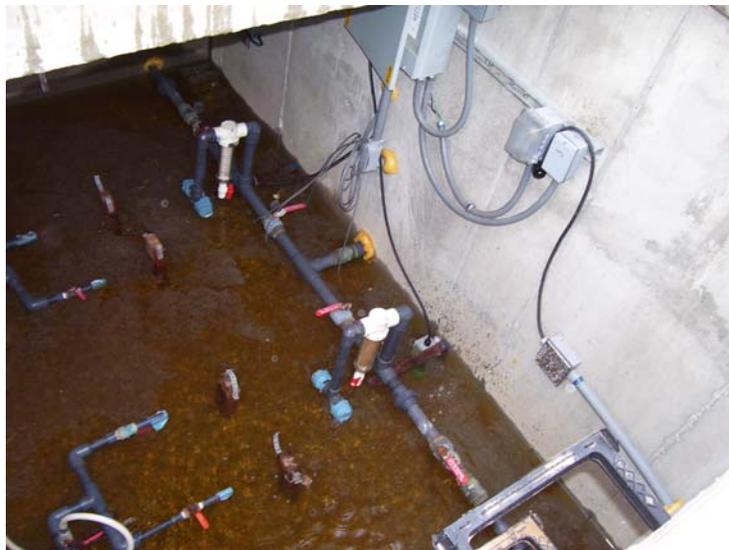
During the peak river flow, the ground water table greatly increased from near 12 ft bgs to 4 ft bgs. Two of the Configuration 4 vaults and three of the Infiltration Trench vaults contained a few inches of standing water. This water originated from the rise in the ground water elevation.

*Water in Configuration 4 Vault.  
Photo Taken June 5, 2008.*

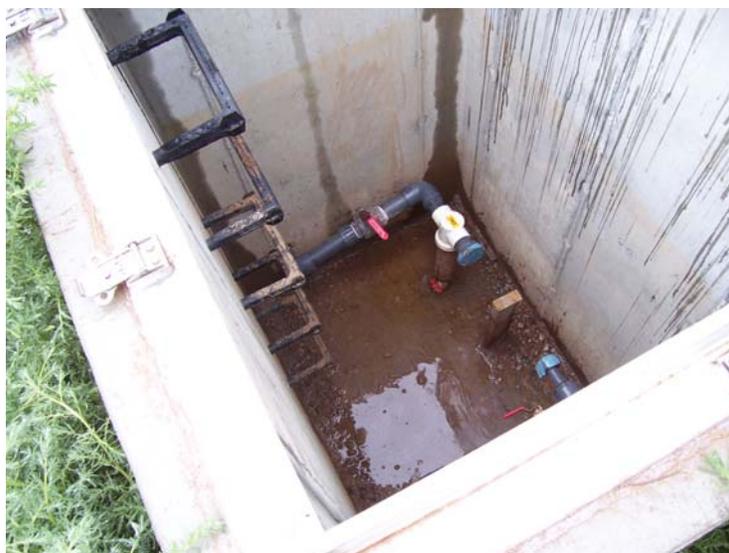
*Water in Infiltration Trench Vault.  
Photo Taken June 5, 2008.*

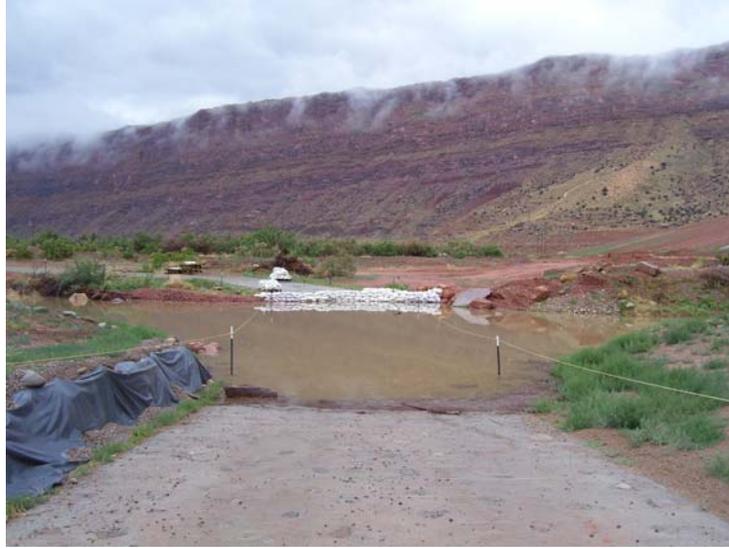
*Moab Wash Crossing on June 5, 2008.*

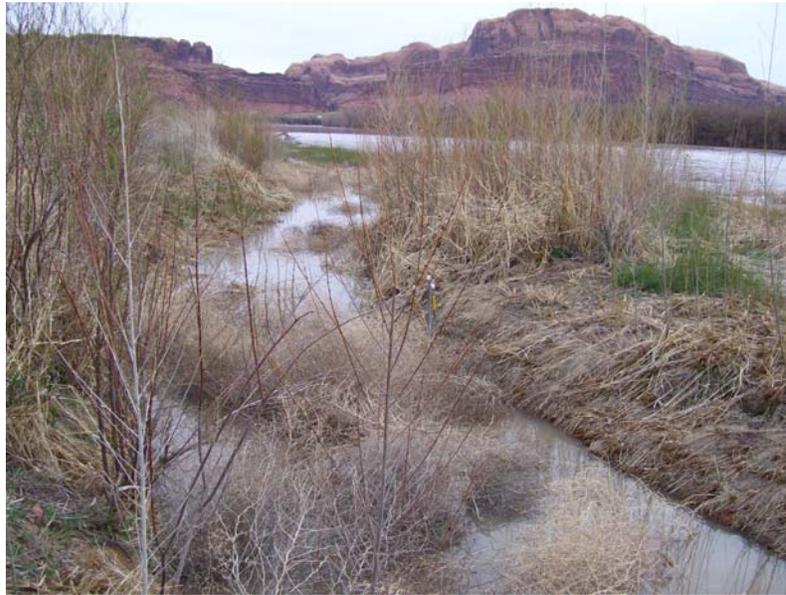
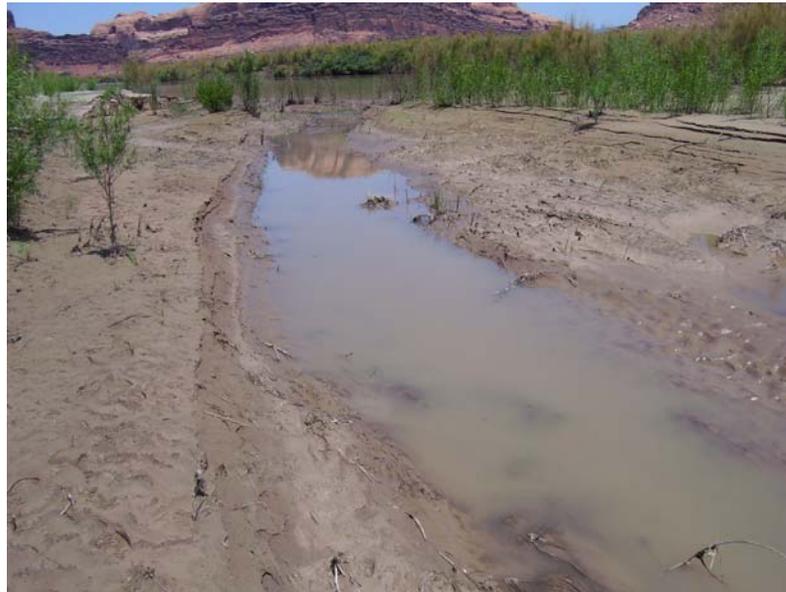
The configuration of the backwater channels adjacent to Configurations 3, 2, and 1 changed dramatically. Approximately 3 ft of sediment was deposited in the intermediate portion of the backwater areas. The intermediate well points at Configurations 3 and 2 were completely buried, and one intermediate well point at Configuration 1 was also buried. Before and after photos of these backwater areas are located in Appendix C.

*Photos of the Backwater Area Adjacent to Configuration 3. Photo (a) Was Taken in March Prior to the Peak Runoff (Note the Well Points Behind the Brush). Photo (b) Was Taken in July After the Peak Runoff (Note the Missing Well Points and the Amount of Sediment Deposit Along the Banks of the Secondary Channel).*

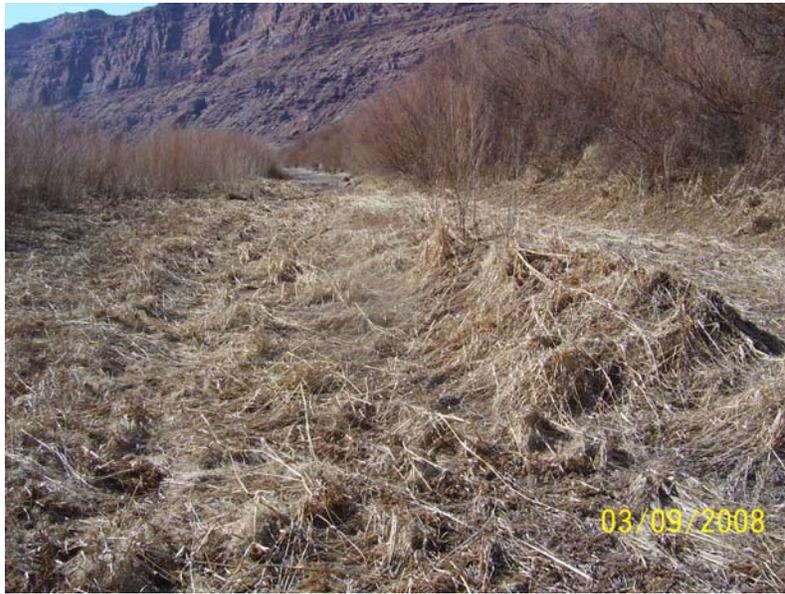
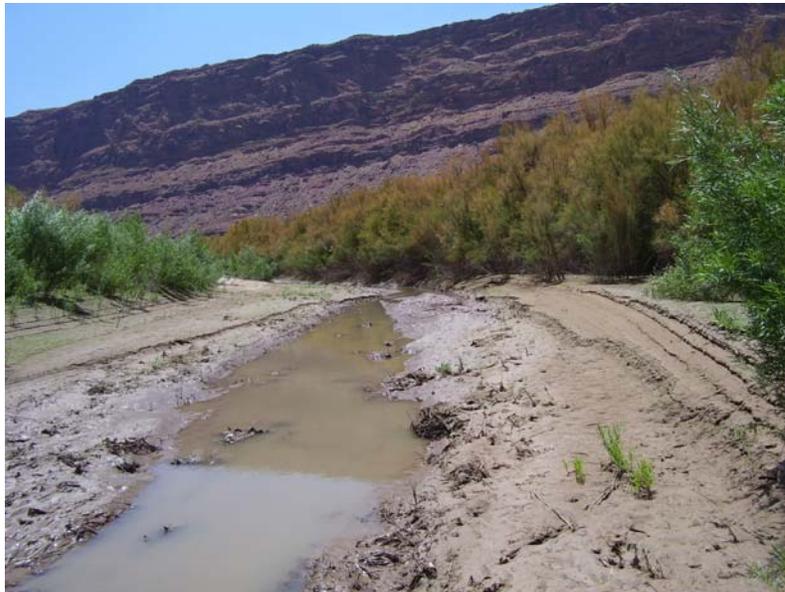
*Photos of the Backwater Channel Adjacent to Configuration 2. Photo (a) Was Taken in March Before the Peak Runoff. Photo (b) Was Taken in July After the Peak Runoff (Note the Terraced Banks and the Amount of Sediment Deposit).*
